November 12, 1991

Reference: Aerial Photograph Analysis  
Hudson Meadows - Diamond Head Oil  
Block 285, Lot 3, 14, and 15  
Kearny, New Jersey  
(91-37238-01)

## AERIAL PHOTOGRAPH ANALYSIS (APRIL 28, 1947)

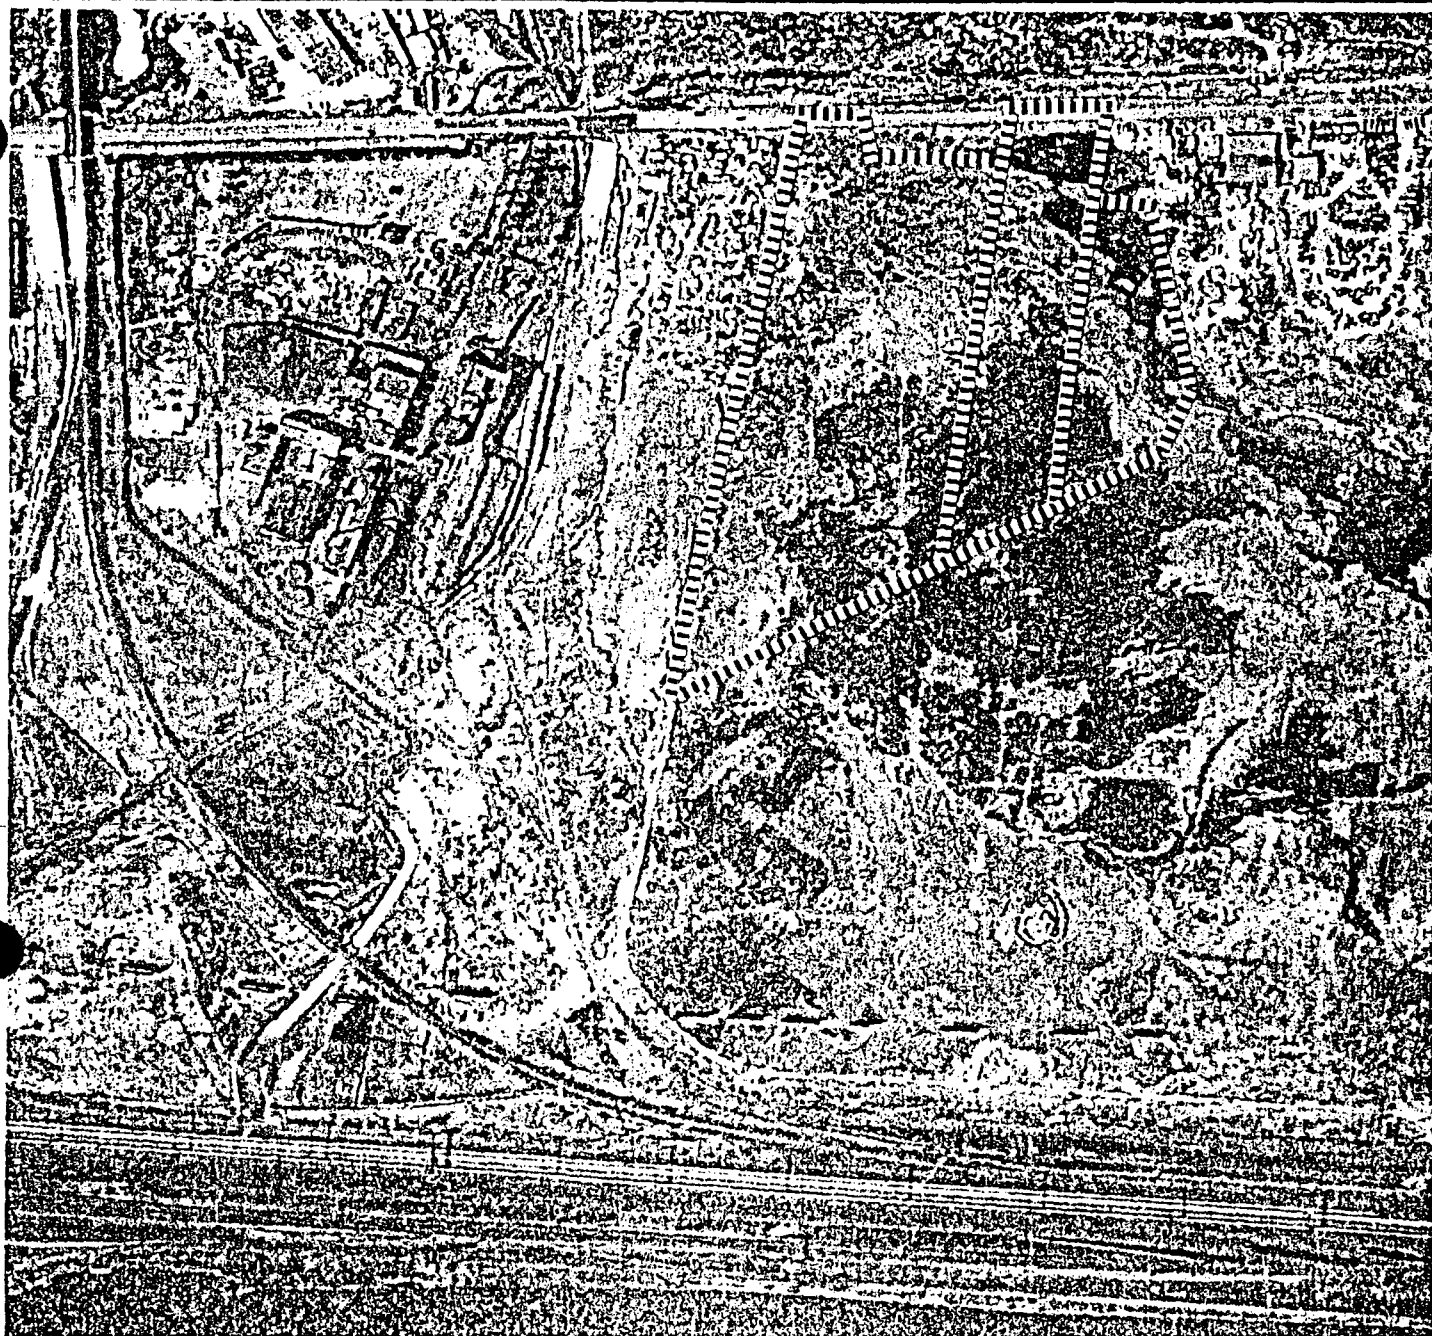
**2**

Figure 2 (April 28, 1947) shows the site at pre-development condition. Land to be east and west of the site is developed and appears to have been used for manufacturing/industrial purposes.

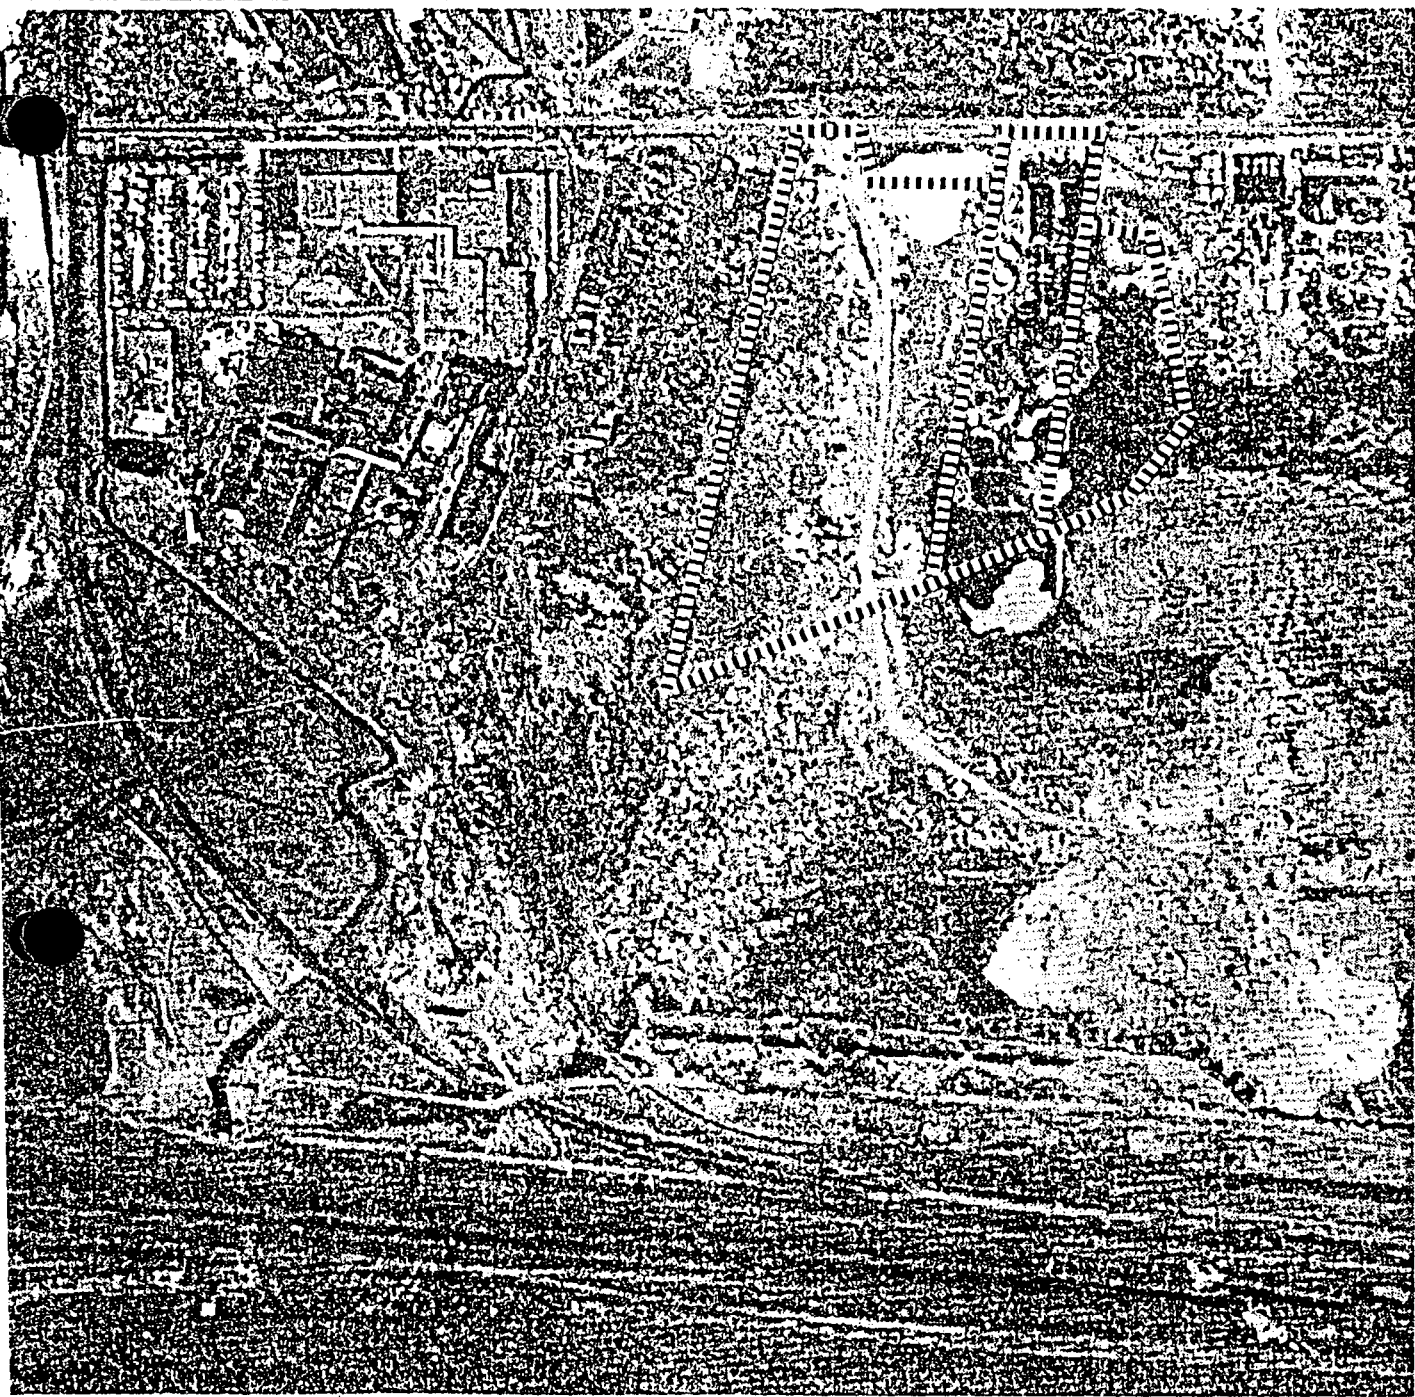
Figure 3 (April 16, 1959) shows the Diamond Head Oil Refinery in operation. Three lagoons and a pond are visible in the southern portion of the property. The Kearny property to the west was being used for landfill operations and an access road runs north-south through the side to the landfill located at the southeast corner of the photograph.

## AERIAL PHOTOGRAPH ANALYSIS (APRIL 16, 1959)

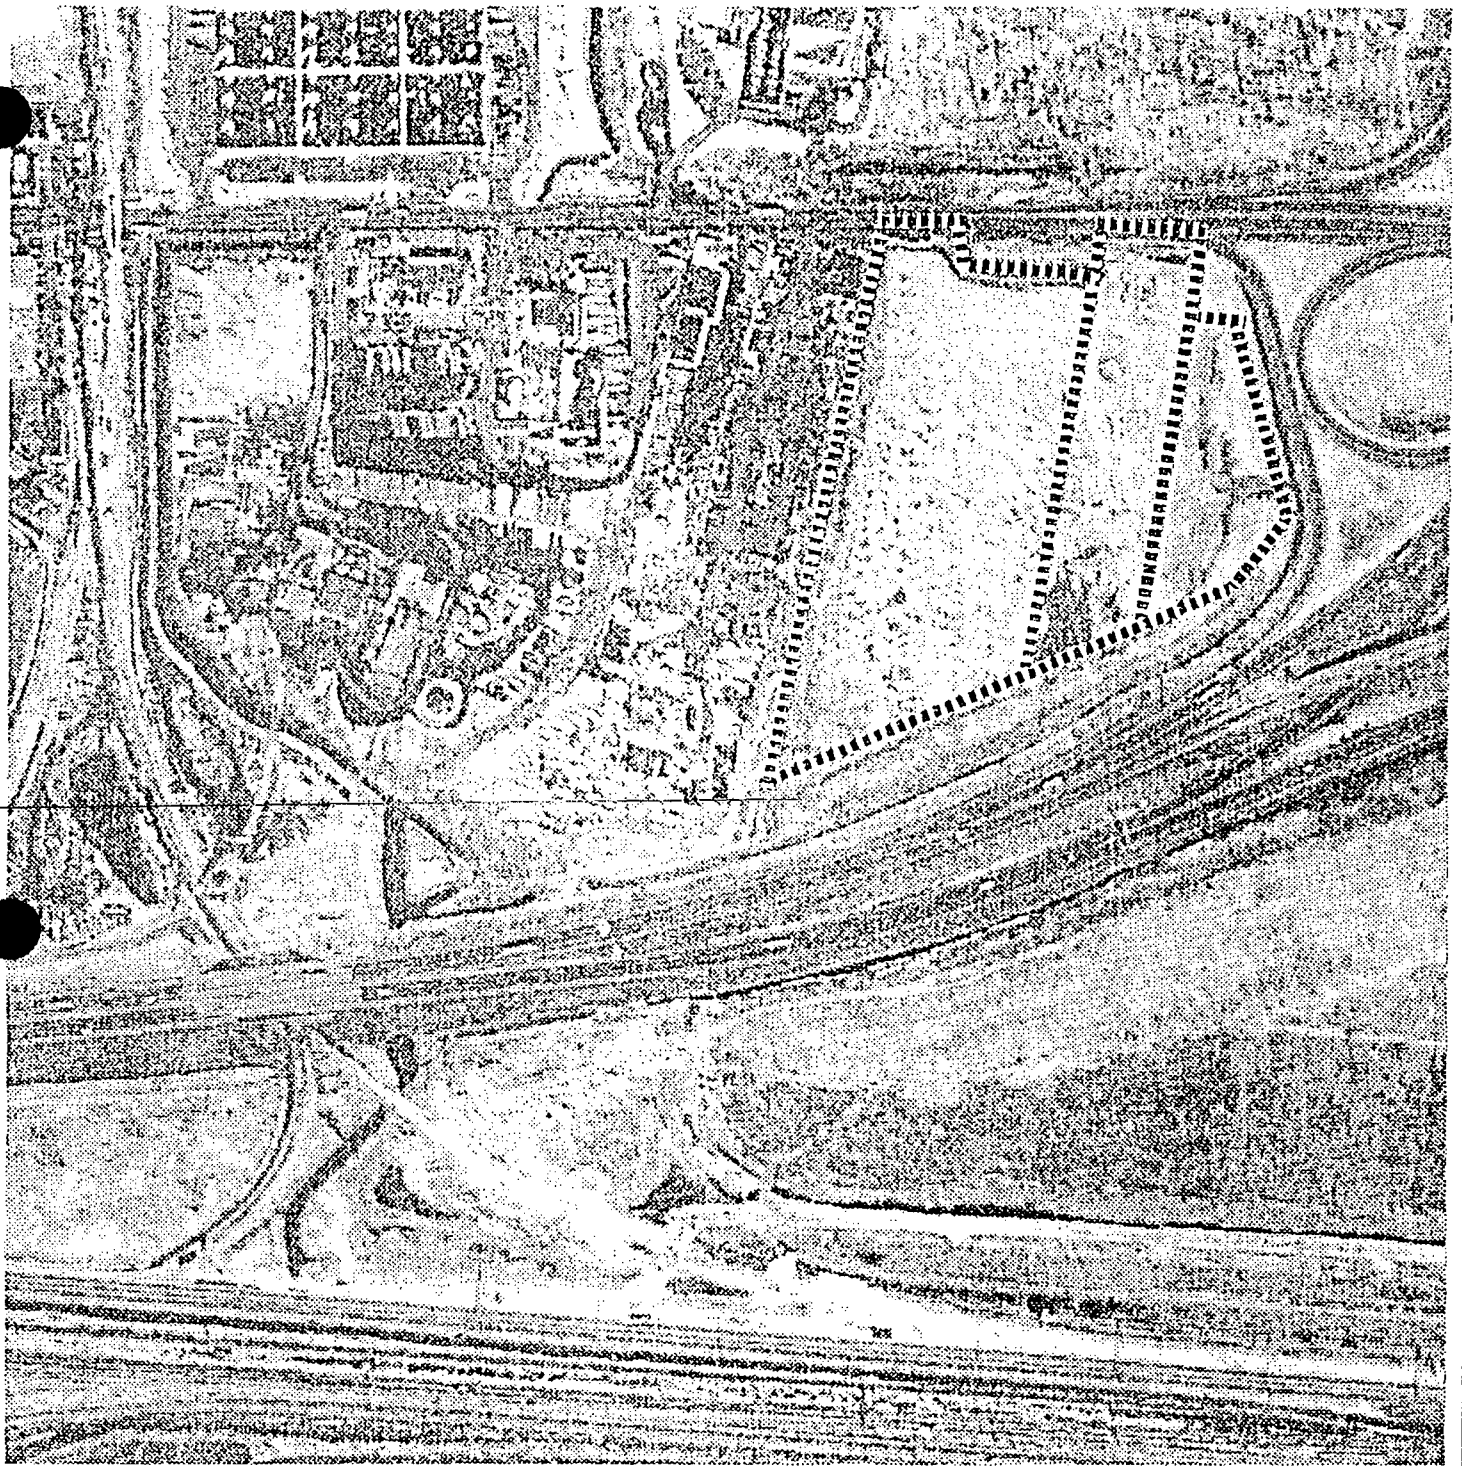
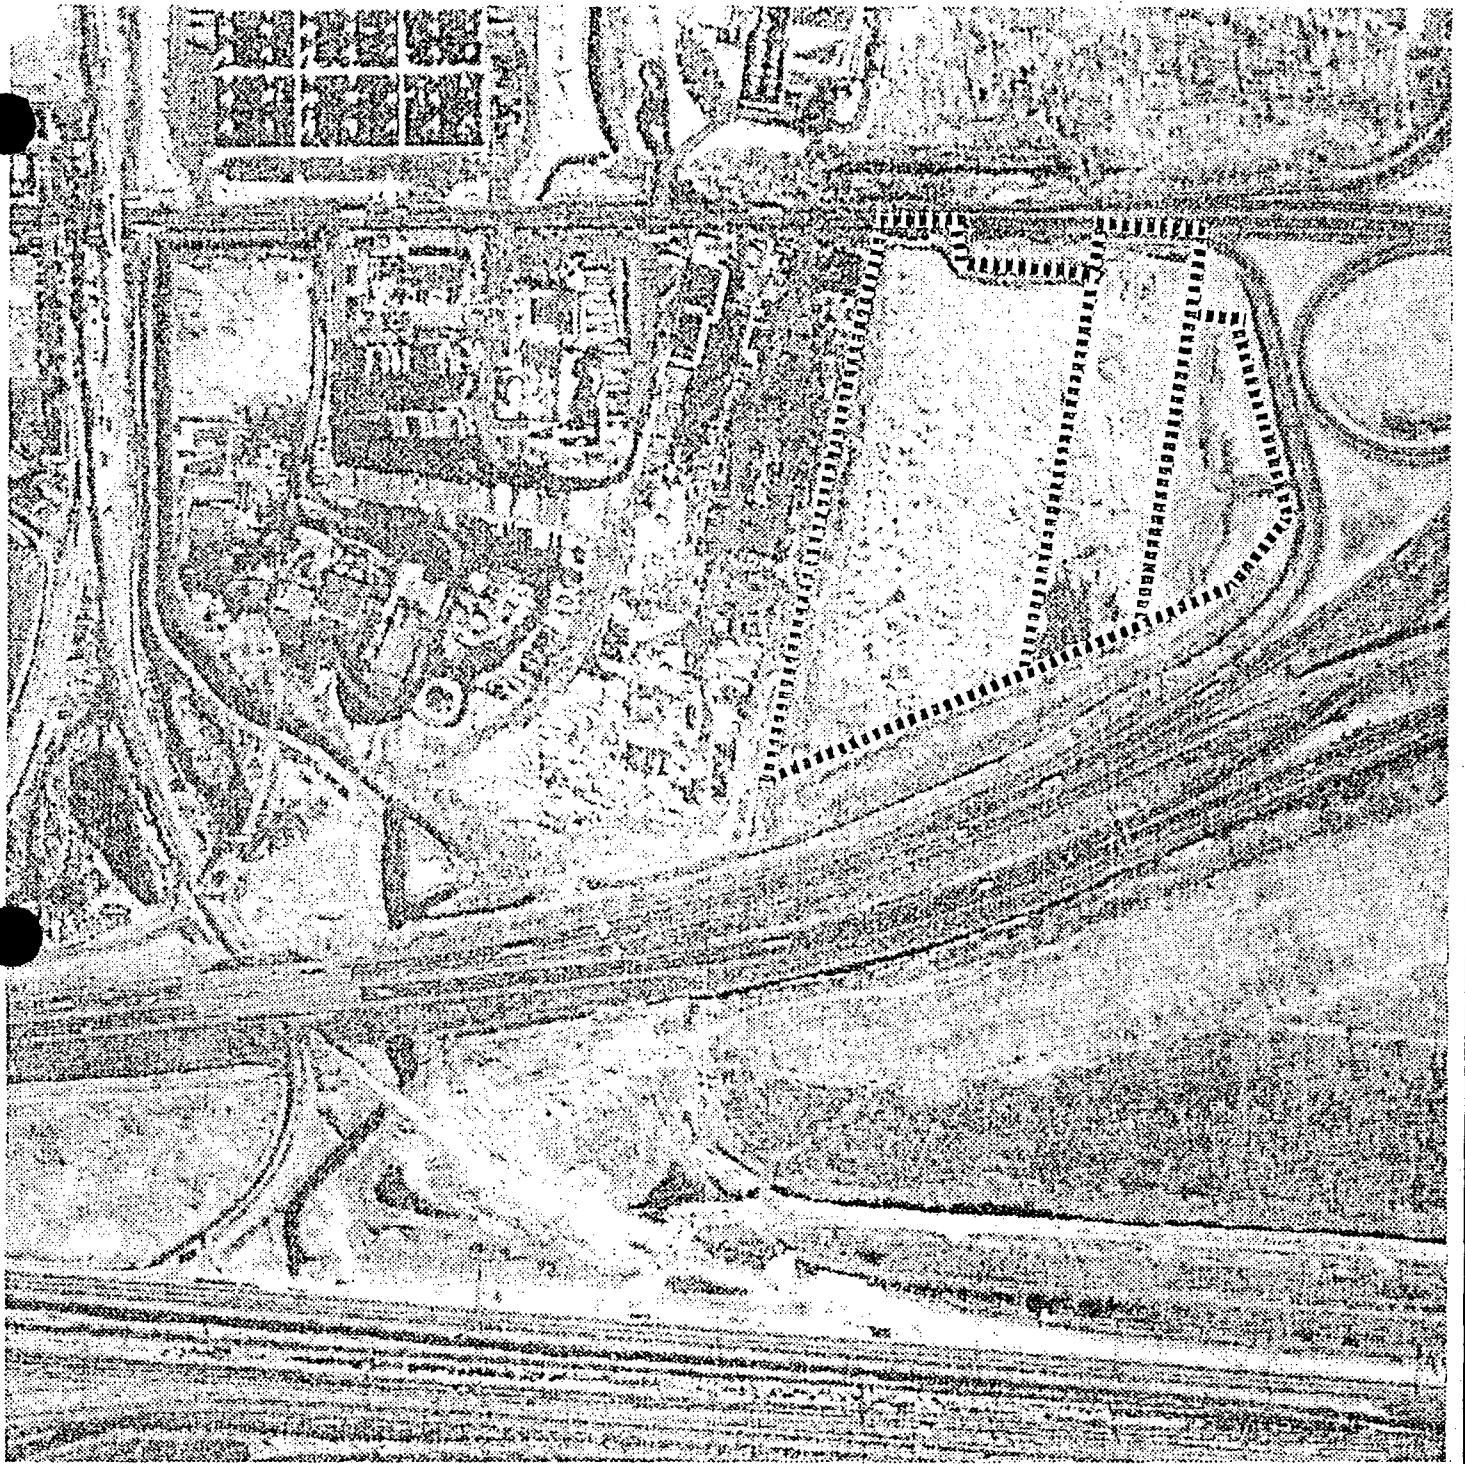
**8**

Figure 8 (March 8, 1990) shows that the site is essentially the same as it existed in 1982. The lagoon, tanks and building foundations are visible (as they were during our site visit in July 1991). The site condition shown in the 1982 and 1990 photographs are judged representative of conditions when Hudson Meadows purchased the site in 1985.

## AERIAL PHOTOGRAPH ANALYSIS (MARCH 8, 1990)
